**MUNICIPAL SEPARATE STORM
SEWER SYSTEM (MS4)
COMPLIANCE AUDIT**

**STATE OF CALIFORNIA,
DEPARTMENT OF TRANSPORTATION**

**REPORT DATE:
February 26, 2010**

**EVALUATION CONDUCTED:
October 5–7, 13–14, and 21–22, 2009**

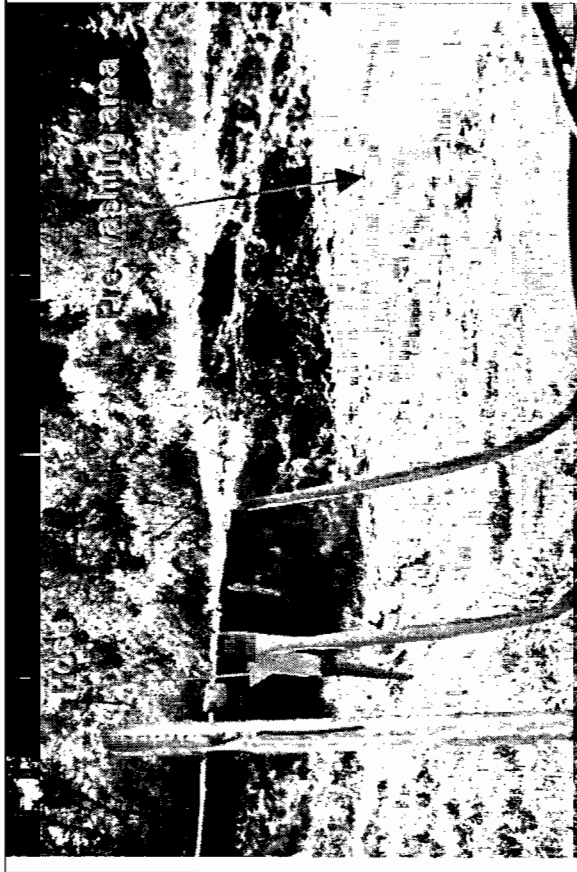
Despite the availability of the designated wash rack, a vehicle pre-washing area was observed in the lower yard (see Photograph 5). The lower yard is located west of the main office and maintenance facility, in much closer proximity to the South Fork Eel River. The pre-washing area is not equipped to properly capture, treat, re-use, or dispose of vehicle wash water and associated pollutants. Additionally, a berm installed down-gradient of the vehicle pre-washing area showed signs of standing water and had been damaged (see Photographs 6 and 7).

Photograph 5— Vehicle pre-washing area in the lower yard

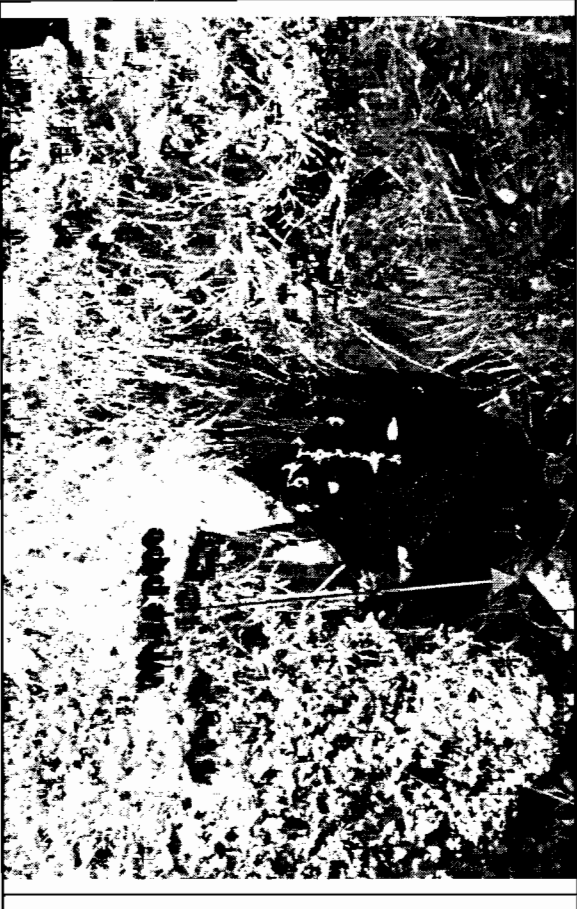
Photograph 10 – Facility outfall

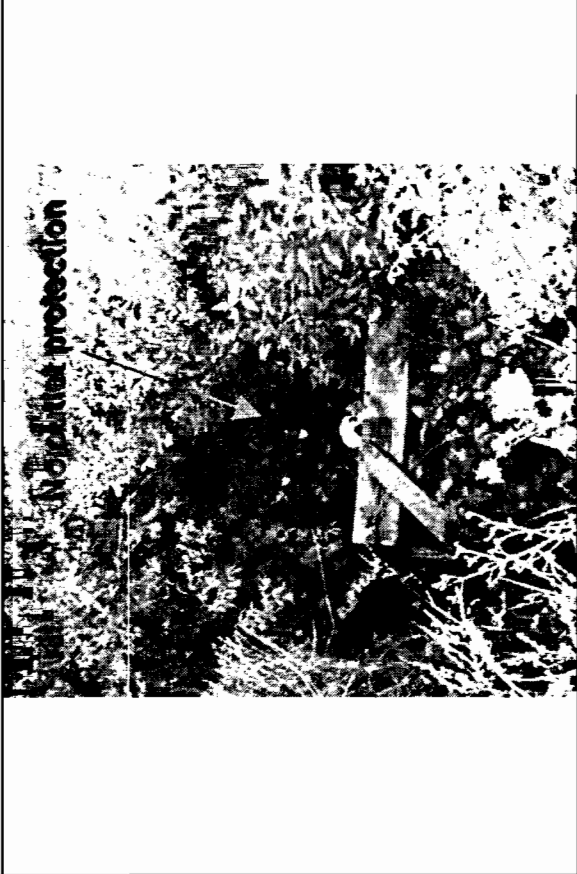
Photograph 12— Proximity of outlet to receiving water
Photograph 11— Outlet pipe down-gradient of facility outfall

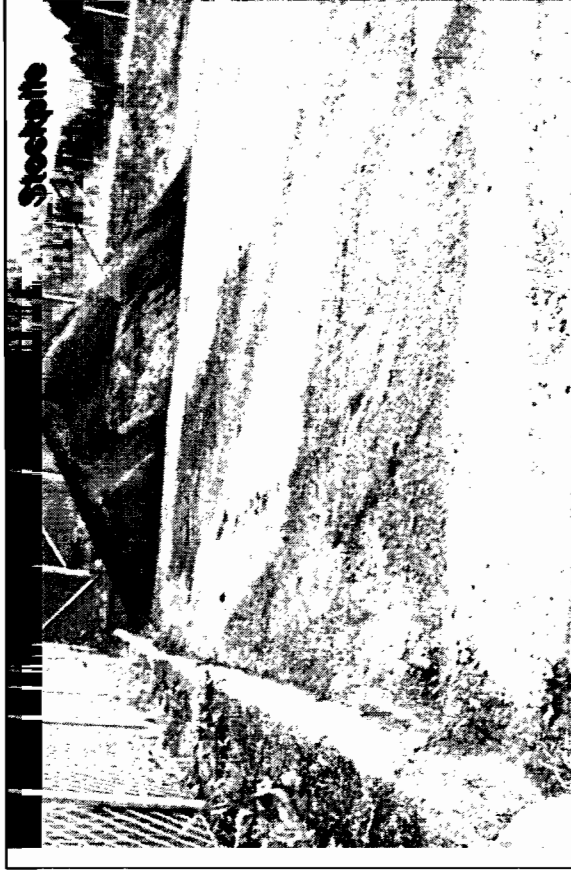
Photograph 1 – Stockpile without BMPs for coverage or containment

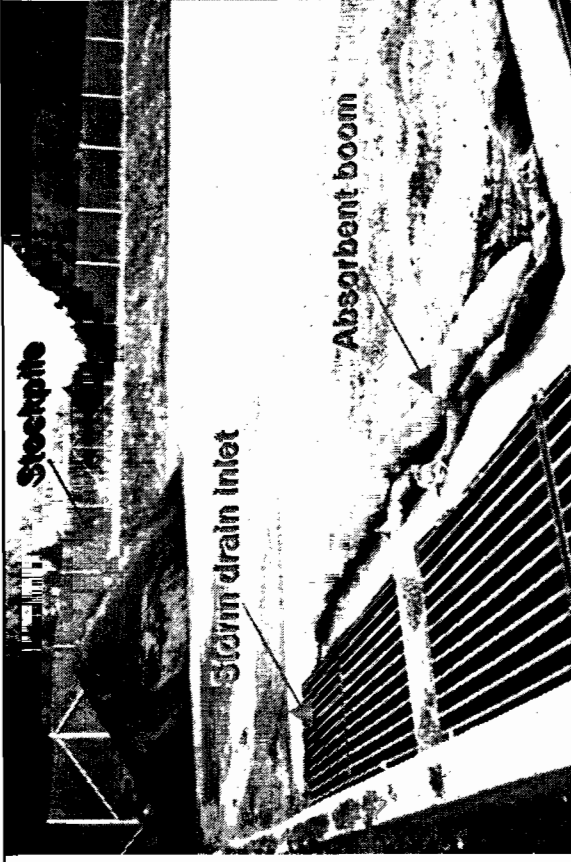
Photograph 2 – View of storm drain inlet and stockpile shown in Photograph 1

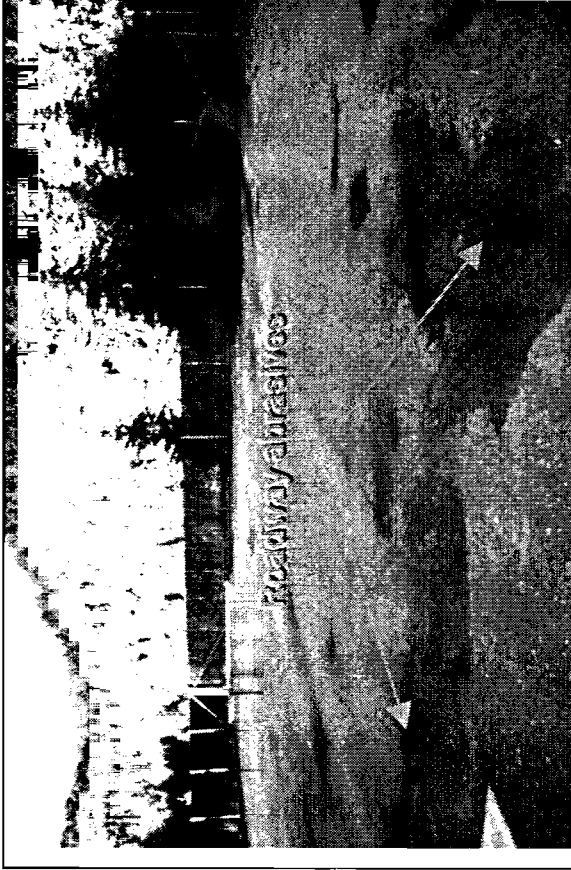
Photograph 5— Roadway abrasives on impervious ground surface

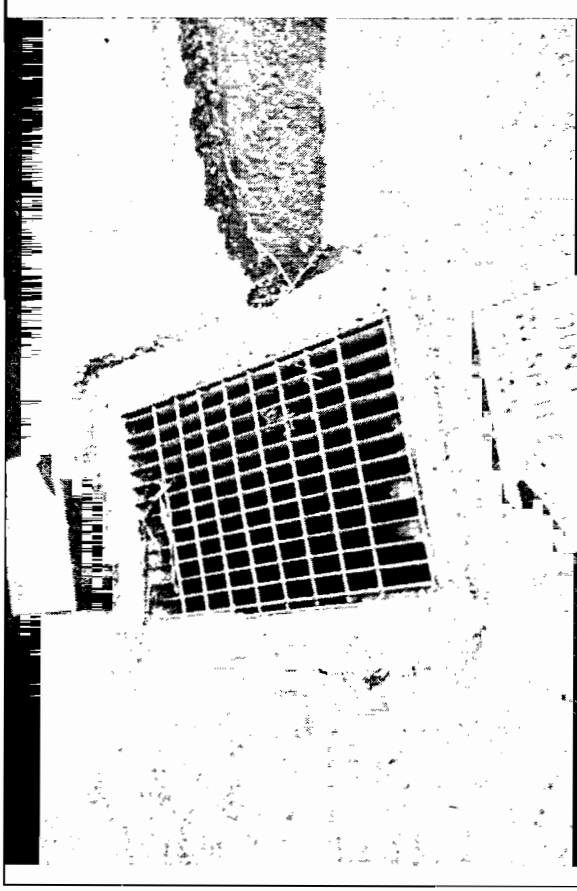
<p>Photograph 1 – Storm drain Inlet at facility</p>

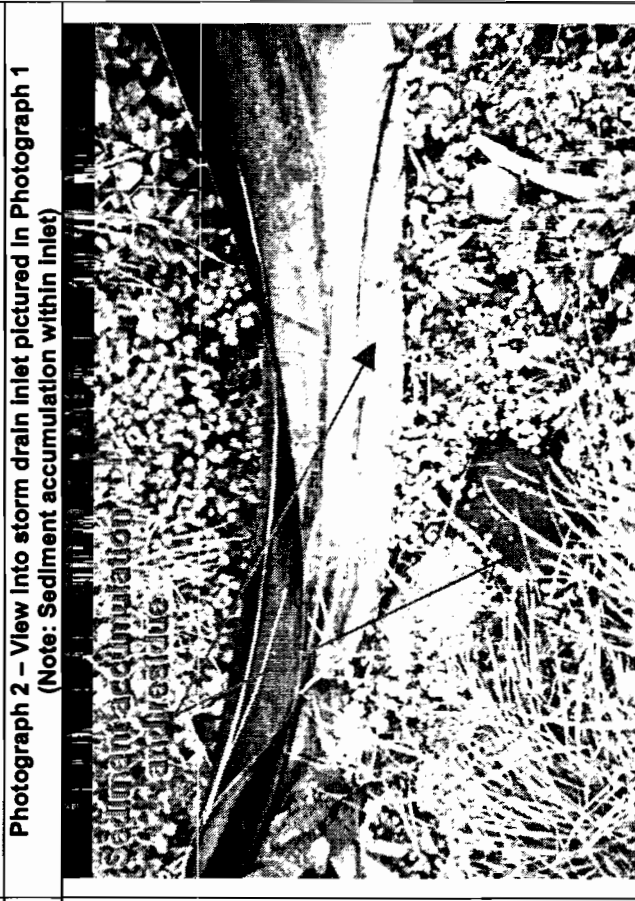
Provision I.3.b of the Permit requires Caltrans to provide appropriate site-specific BMPs for all maintenance facilities. A significant amount of sediment accumulation was observed within a storm drain inlet at the facility that did not appear to have been recently cleaned (see Photographs 1 and 2). As explained by the Highway Maintenance Supervisor, storm drain inlets at the facility flow to the drainage ditch in the southeast corner of the facility (see Photograph 3). He added that storm water runoff does not generally discharge off-site from this location but rather ponds and remains as standing water until it infiltrates into the ground. Nonetheless, evidence of sediment discharged to the drainage ditch as well as sediment accumulation within the culvert pipe that discharges to the southeast corner of the facility was observed (see Photograph 5). Furthermore, a silt fence BMP had been installed in the flow pathway of the culvert outlet and was not entrenched into the ground to retain sediment and prevent failure (see Photograph 3).

<p>Photograph 3 – Storm drain outlet to drainage ditch in southeast corner of facility</p>	<p>Photograph 4 – Closer view of silt fence BMP shown in Photograph 3</p>

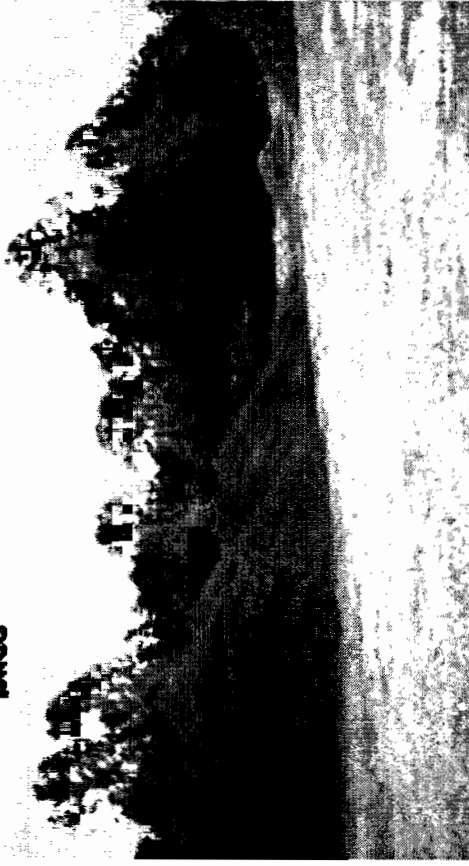
No BMPs for storage
piles

Photograph 1 – View of stockpiles

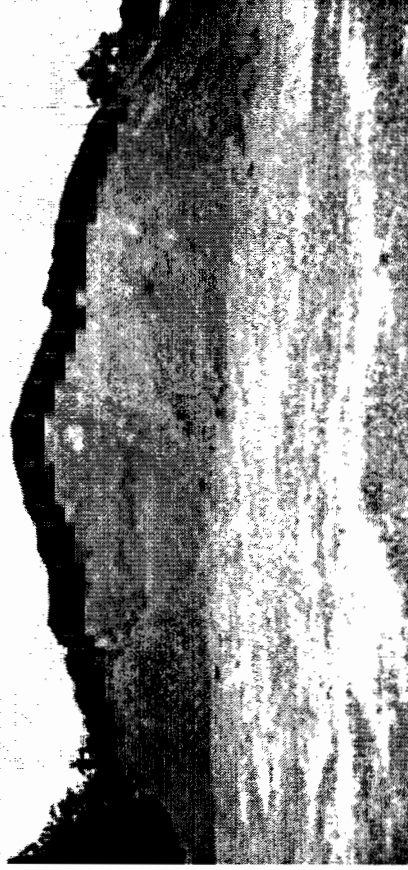
Photograph 2 – Lack of BMPs to contain stockpiled materials

Drainage ditch flowing
to storm drain

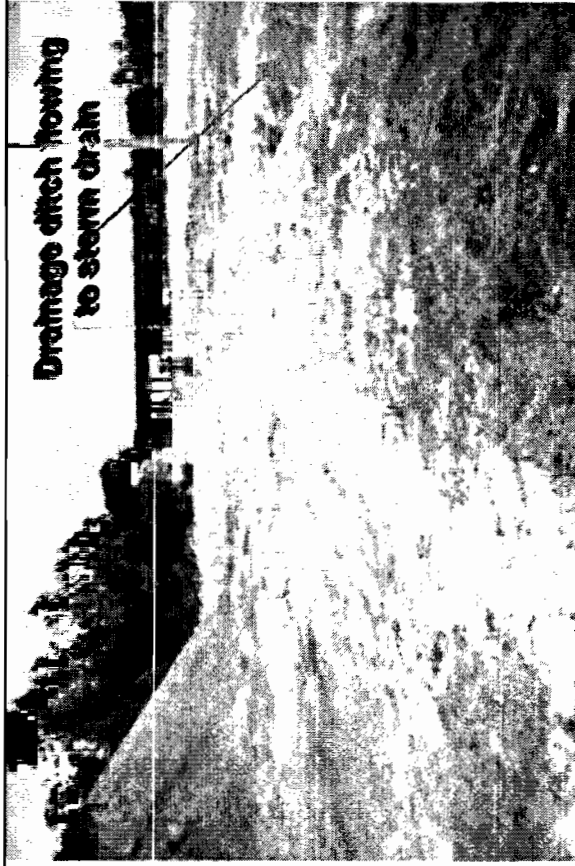
Photograph 3 – View of Photograph 2 stockpile proximity to drainage ditch
